CHARACTERIZATION OF HIGH POWER GAS SWITCH FAILURE MECHANISMS

E. E. NOLTING

Naval Surface Weapons Center
White Oak, Silver Spring, Maryland 20910

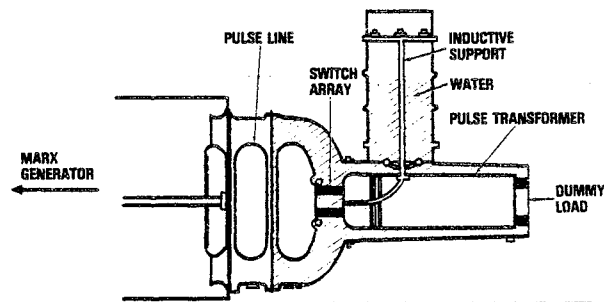
The entire switch column assembly was rigidly connected at the positive (output) end of the switch. At the opposite end, the switch columns were attached to a plate which was electrically connected by several short, braided straps. This cantilevered switch assembly allowed shifting of the pulseline and transformer, when transmission line fluids were transferred, without creating stresses in the switch components. Figure 2 shows location and mounting of the switch assembly.

Fig. 2. Experimental arrangement used for testing gas switches on the Casino simulator.
